Bolted Connector Failure as a Result of Improper Construction Procedure/Management

Charles C. Roberts, Jr., Ph.D., P.E.
C. Roberts Consulting Engineers, Inc.
P.O. Box 118
Rochelle, IL 61068 USA
www.croberts.com

Case Study: Roof Support Failure

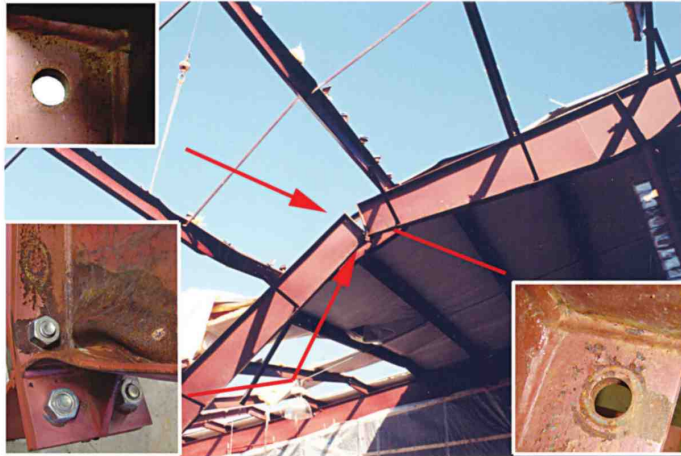
Fig. 1 — View of a bolted connection that failed as a result of snow loading on a roof.

Figure 1 is a view of a bolted connection that failed as a result of snow loading that should have been within the capacity of the roof to support. The building was approximately six years old. The bottom portion of the beam connection that failed had four bolts properly installed. The upper portion of the connection flange was designed to have two bolts installed. There was evidence of a bolt having been installed in one of the holes (lower right in Figure 1), but no evidence of a bolt having been installed in the other upper flange hole (upper left in Figure 1).

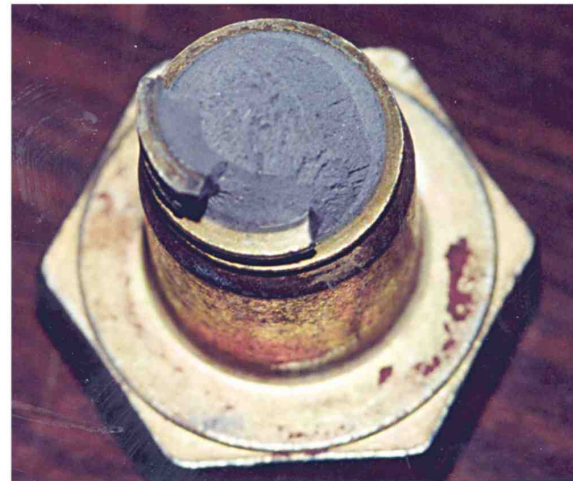
Figure 2 shows the fracture surface of the fastener (ASTM A325 Type 3 high-strength structural bolt) that failed at the upper flange. Analysis of the fracture surface showed evidence consistent with an excessive load applied to the fastener. No deficiencies were found in the bolt metallurgy that could have caused or contributed to a failure. Only one failed bolt was found at the scene.

Fig. 2 — Fracture surface of the fastener that failed at upper flange.

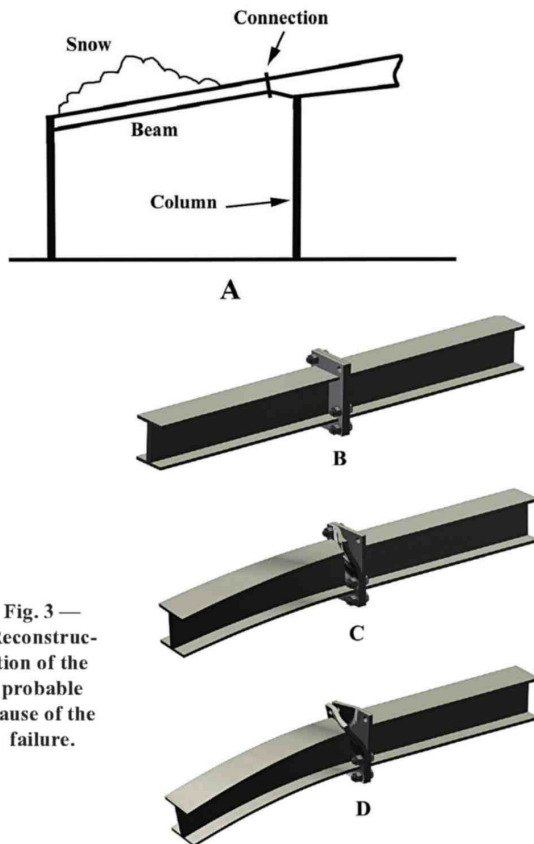
Figure 3 aids in reconstructing the probable cause of the failure. Wear patterns on the upper holes of the flange connection suggest that one bolt was installed, while the other bolt was not installed.

Figure 3B shows the connection under uniform loading, before failure, such that the lower bolts are in tension and the upper bolts in compression (also called sagging). With the missing bolt, the connection will support the designed uniform load along the beam since the bottom bolts are in tension while the upper bolt is carrying very little load other than the pre-load. As long as the sagging bending moment is

In Figure 3A, the snow loading at the time of the failure is shown, which applied bending moments to the beam and connection such that the upper bolts were in tension and the lower bolts in compression (also called hogging). With the onset of a hogging bending moment as experienced in this particular unsymmetrical snow load, the lower bolts are not carrying much tension, but the upper bolt is, and in an unsym-

metrical fashion, because of the bolt offset (Figure 3C). This overloaded the bolt, resulting in failure of the upper part of the connection (Figure 3D) and roof collapse. Structural calculations showed that if both of the upper bolts had been installed properly, the failure would probably not have occurred.

The absence of the fastener was the probable cause of failure, suggesting a problem with construction procedure/management. During steel erection, bolts are often installed with nuts that are hand tightened to make sure the connections all fit. They are then tightened to the proper torque before normal loading is sustained by the structure.

Fig. 3 —
Reconstruction of the
probable
cause of the
failure.

Apparently no inspection was performed or only a cursory inspection was performed, resulting in a missing bolt at a critical part of the structure, which was not rectified. Clearly the fastener itself was not at fault in this case.

In some instances, only a few of the flange bolts are inserted to align the structure before final assembly, which can result in missing bolts if no inspection is performed. Occasionally, flange connection holes do not line up and some fasteners cannot be installed, which should be reported to management. The purpose of an inspection is to verify that all bolts have been installed.
