Reprinted with
permission from the
August 2015 issue of
Claims magazine

Under Water: Pipe Failure & Electric Current-related Corrosion

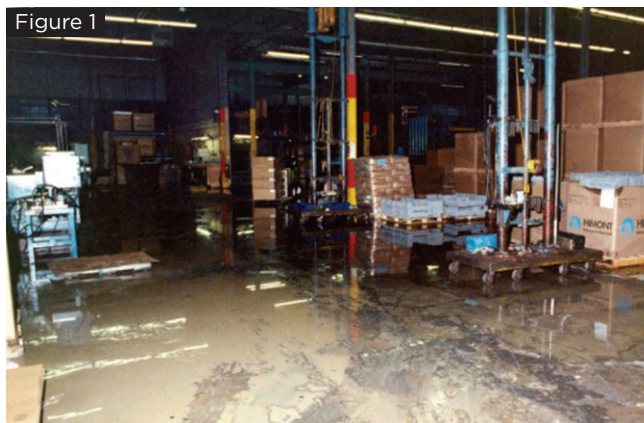
The following case study illustrates a water leakage loss as a result of a failed underground pipe. Figure 1 is a photograph of a large industrial building that sustained a substantial water loss from a failed four-inch water pipe near an exterior wall. The underground pipe was sufficiently close to the exterior wall that once the leakage occurred, the water was able to enter the building, causing significant water damage to the products and machinery.

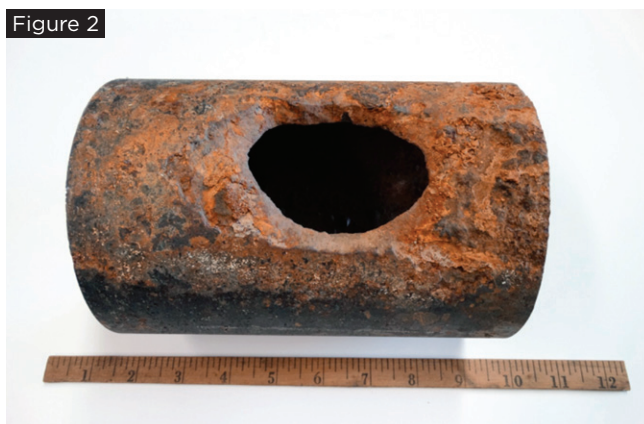
Figure 2 is a view of the opening in the pipe that was the source of the leakage. There was severe localized corrosion in the pipe wall in this area. As shown in Figure 3, the corrosion was not occurring along the entire length of the pipe underground. At approximately five inches on each side of the hole, the wall of the pipe was in good condition with no decrease in wall thickness from corrosion.

There was no active corrosion control in the form of DC voltage control or sacrificial anodes. There was no protective wrapping or coating on the iron pipe. This type of corrosive attack is characteristic of electrical current flow to ground. It is not uncommon to use a piping system as a ground for electrical equipment in a plant. What happens is that the electrical current flows along the pipe and may exit randomly at a location in the soil which is conductive and at a lower voltage. This results in rapid corrosion of the exterior of the pipe in a localized area, which was the issue in this case.

The root cause of the loss is insufficient corrosion protection of the pipe. Retaining the failed pipe, taking statements of the insured's personnel, documenting information regarding the loss and obtaining an engineering failure analysis report will aid in a successful recovery for the insurance adjuster's client. 🍷

Corrosion control on this particular piping system was lacking. The designer of the piping system should have provided adequate corrosion control. Typical methods of corrosion control are external coatings, polymer wrap, cathodic protection and

material selection.
