Water Faucet Fitting Failure Causes Significant Damage

EMPHASIS: Fastener Failure

Charles C. Roberts, Jr., Ph.D., P.E.
ccr@croberts.com

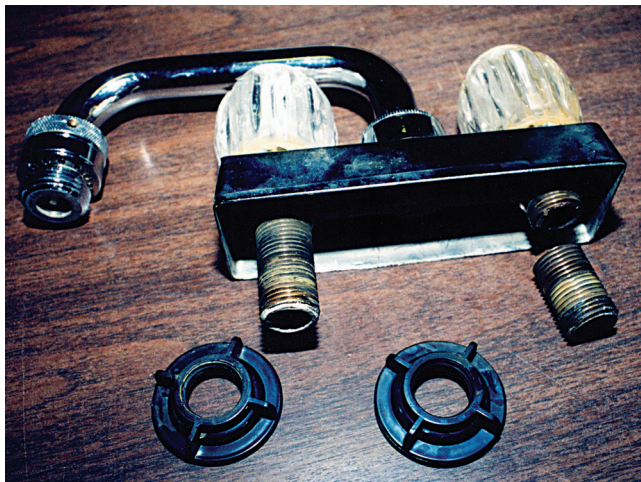
Faucets are typically secured to a sink using metal threaded pipes and polymer nuts as shown in **Figure 1**. In the particular case seen in **Figure 1**, the threaded pipe failed in the vicinity of the nut, causing significant damage to a home. This was on the hot water side of the faucet.

Fig. 1 — Faucets are usually secured to a sink using metal threaded pipes and polymer nuts.

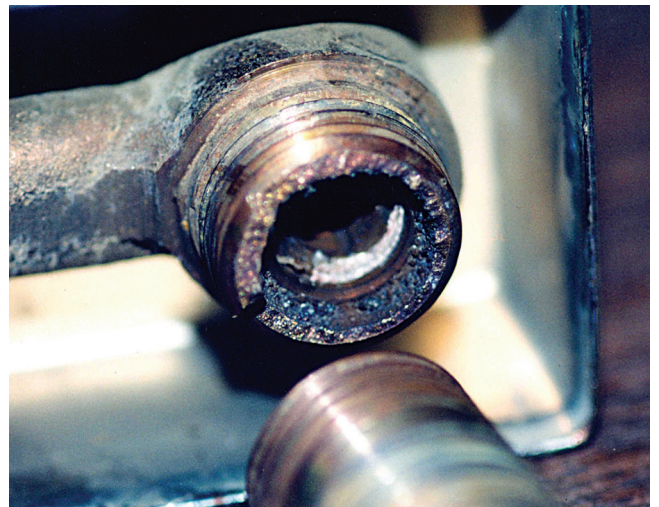
Figure 2 shows the fracture area of the cast brass faucet fixture. **Figure 3** and **Figure 4** show close-up photos of the fracture surface. The arrows in **Figure 3** and **Figure 4** are in the area of the fracture origin and also show the apparent thinner wall thickness in this area.

Fig. 2 — Fracture area of cast brass faucet fixture.

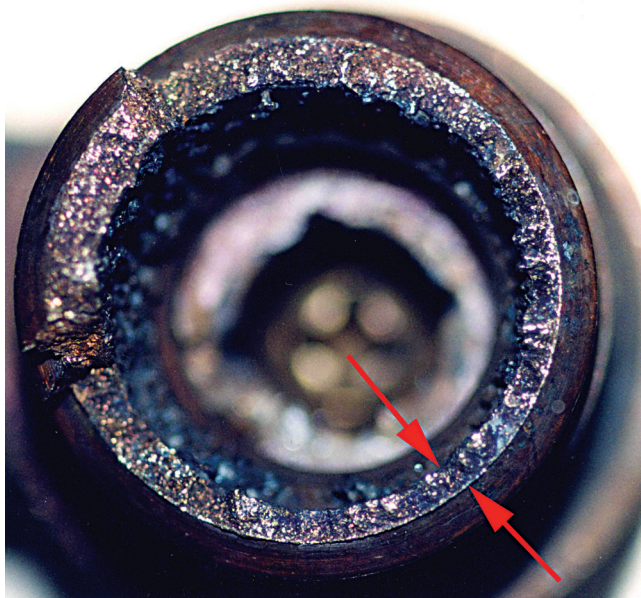
the circumference. The thickest portion of the pipe wall is at the 10 o'clock position. The thinnest is at the 5 o'clock position, near the arrows.

Cutting of the pipe thread further reduced the cross section, especially at the thinned area indicated by the arrows. This condition resulted in increased stress from installation preloads and thermal loads.

The thermal cycling provided fatigue-related loading, which lead to the eventual failure of the threaded fitting. The defect here is the circumferential variation of pipe wall thickness such that the thin section of the pipe wall is over-stressed, which is most likely a quality control manufacturing problem.

Fig. 3 — Close-up of fracture surface.

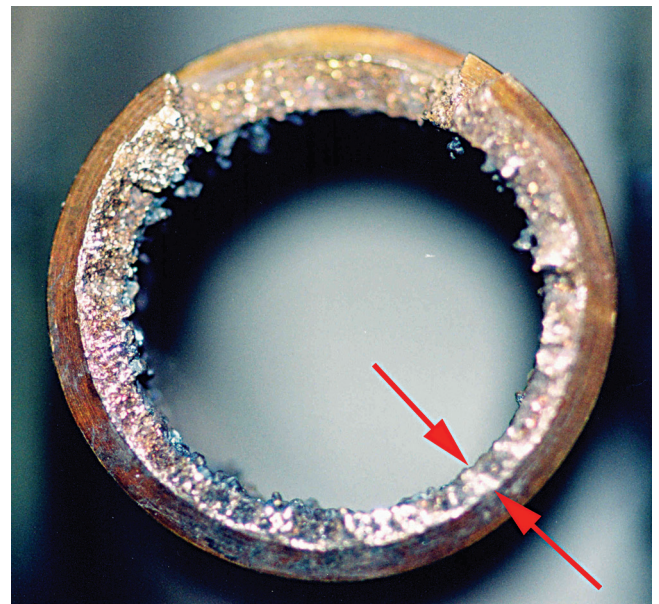
Fig. 4 — Close-up of fracture surface.
