Brake Lock Up Causes Fire in Trucks

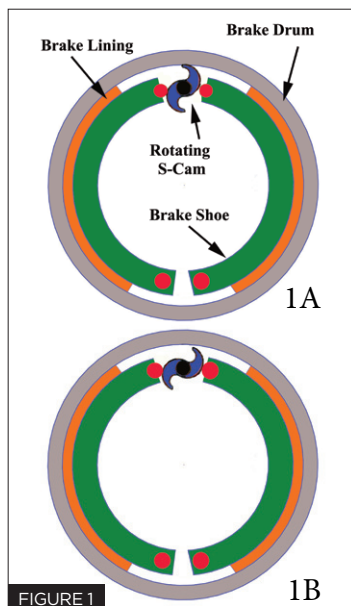
Figure 3 is a view of the brake system from the wheel, indicated by the red arrow

in **Figure 2** that caused the fire. Thermal patterns indicated this to be the brake drum that had a problem. Upon removal of the brake drum, one of the brake shoe rollers fell out. The blue arrow in **Figure 3** shows the position of the missing roller. The red arrow in **Figure 3** shows the S-cam to be in a position nearly overriding the brake shoe roller. With the S-cam in this position, it has exceeded the travel expected in the design. In this position, the S-cam will not return to the released position (**Figure 4**), causing uncontrollable brake pressure, severe frictional heating and a fire.

Figure 5 shows severe thermal damage to the brake lining as a result of the jammed S-cam. The root cause of the failure involves worn out brake linings and drum. The linings and the drum had insufficient thickness to prevent the S-cam from traveling into the jammed position.

This is a maintenance-related item, which is the responsibility of the entity performing the maintenance. The dispatcher also bears some responsibility in instructing the operator to drive the vehicle to the maintenance facility. ❗

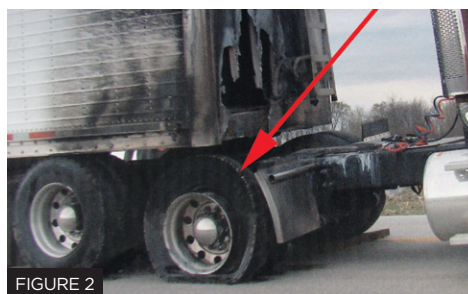
Figure 2 is a view of a road tractor showing the results of a fire that started in the area of one of the brakes. The truck was moving when the driver no-

ticed a problem with one of the right rear brakes on the tractor. He called his dispatcher and was advised to release the brake chamber linkage and proceed to a maintenance facility. On the way to the facility, the right rear tires caught fire and the tractor and trailer were damaged. The driver had disconnected the brake chamber linkage, assuming that the S-cam would return to the no-brake position (**Figure 1A**). In fact, the brake was locked and continued driving, eventually caused frictional heating and a fire.
