Swept Away: Failure Analysis of a Sign

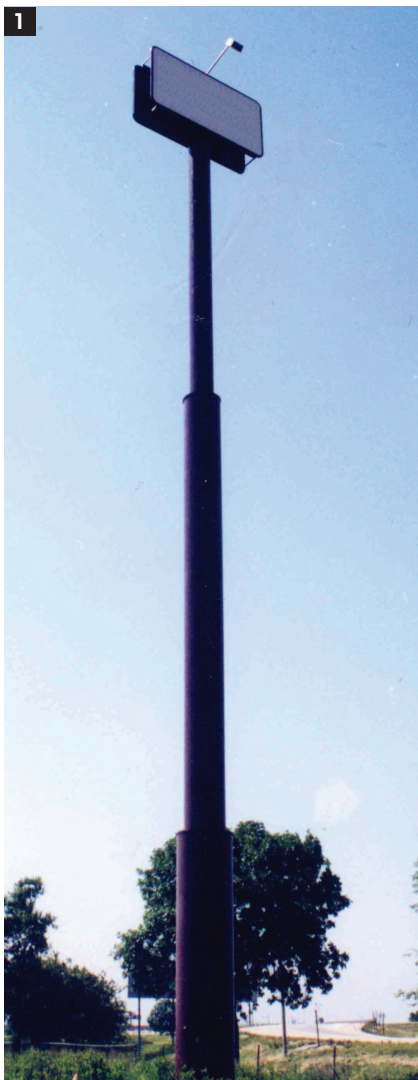
Figure 1 is a view of a typical large sign advertising the location of a motel off an interstate highway.

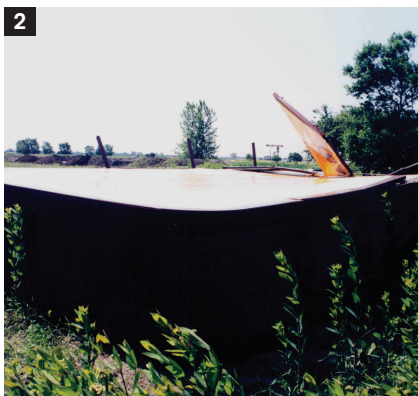
Figure 2 shows a sign that failed during a windstorm where wind speeds approached 70 MPH. The sign was designed to withstand winds on the order of 90 MPH.

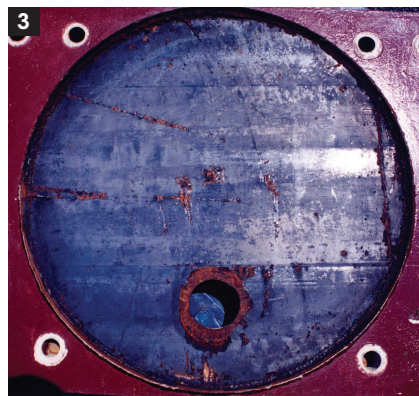
Figure 3 shows the sign base plate, which is one-inch thick steel bolted to a concrete pier. The sign column tube has failed at a weld at the base plate. Wind-induced vibration has caused the weld to be overstressed, resulting in a dynamic fracture of the weld. Essentially, the weld unzipped. A close-up inspection of the weld showed the existence of several imperfections in the weld.

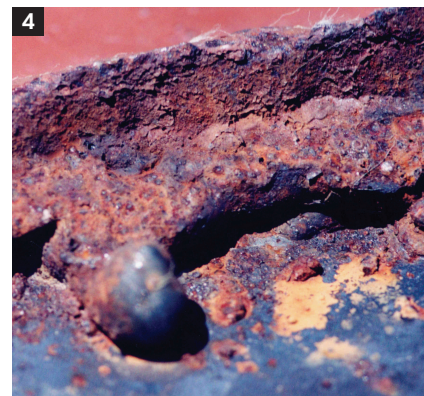
Figure 4 is a close-up of a portion of the weld showing severe undercutting and lack of penetration in the weld. Lack of penetration or fusion in a weld forms small cavities and crevices in the weld, reducing weld cross-section and strength. Over time, pitting in the

cavities and crevices is subject to further degradation from crevice corrosion.

The formation of cavities is a result of poor welding procedure including improper electric current setting, improper electric arc length, improper electrode angle and lack of skill in movement of the electrode over the weld. An undercut results from excessive current and improper technique when welding, causing loss of base metal, a reduction in cross-section and weld strength. Although the wind speed was reportedly near 70 MPH, the sign should have survived without failure. The likely cause of this failure is a deficient weld that was over stressed by the wind conditions. ❧
