# EVALUATING CRACKS IN BUILDINGS

Charles C. Roberts, Jr., Ph.D., P.E.

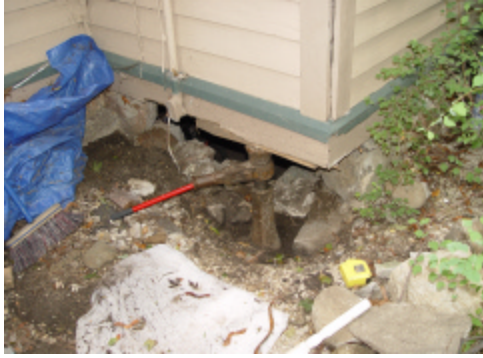
Figure 5 is an example of a partial collapse of a foundation, which is common among older stone foundations. Mortar has deteriorated and stones have fallen into the basement area. The loss of structural foundation support has caused cracking of drywall in the building interior. This is a form of deterioration.

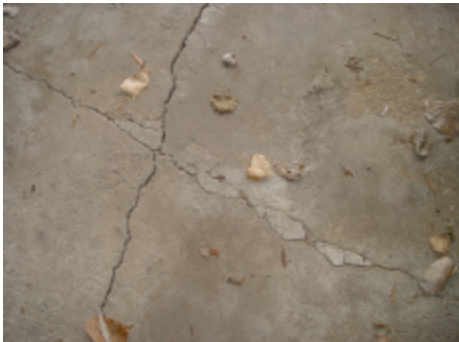
Figure 6 is a view of a typical garage floor slab X pattern crack, a symptom of up and down soil movement over time. Chunks of dust and concrete debris have become embedded in the cracks, suggesting that they have formed over time. This is a form of settling.

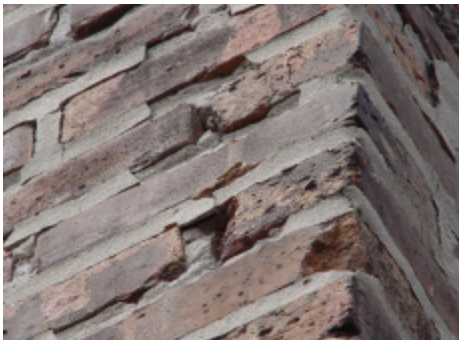
Figure 7

In Figure 7, flaking and fracturing of brick and

mortar joints has caused structural instability and further cracking in the brickwork that is not deteriorated. This type of cracking is typically long term related and a form of deterioration.

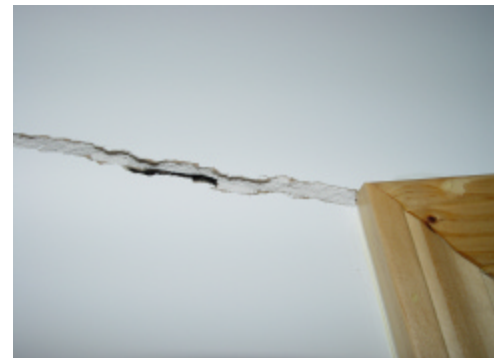
Figure 9 shows a long crack in new wallboard with a width of about an inch at the corner of the door frame - a relatively large crack displacement. This crack was formed instantaneously as a result of a natural gas leakage fueled explosion in the building.

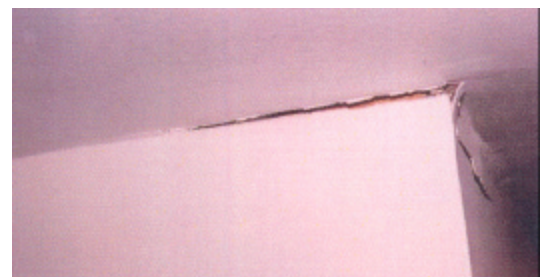
Figure 10 shows cracking of wallboard in an upstairs bedroom in the center of the home as a result of truss uplift (Claims Magazine, February 2001). Because of larger amounts of insulation in attics in recent years, the lower cord of trusses tends to dry out and shrink, causing an uplift of the truss in the middle. This can generate unsightly cracks in wallboard unless the installer had taken care to allow more flexure of the wallboard in areas of large deflection. This is a result of improper construction.

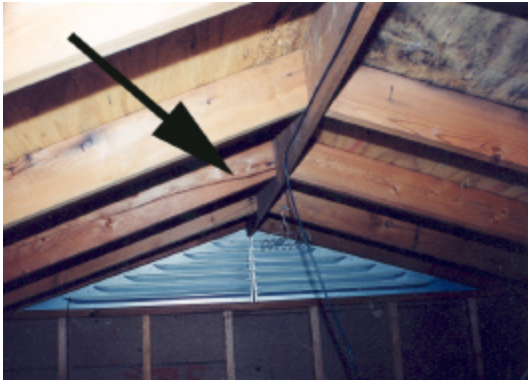
Figure 11

In Figure 11, severe cracking was occurring in roof rafters of a residential home. The framing lacked any collar ties, which tended to over stress the frame connection. Collar ties are boards that connect opposite rafters at about two thirds the height from the floor to the ridge board. This is considered a construction defect.

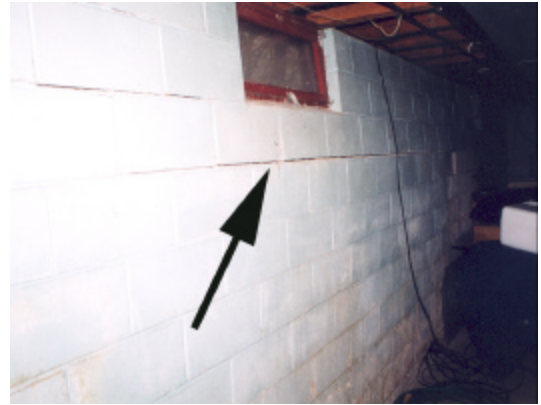
Figure 12 shows a horizontal crack in a block wall about halfway up the wall. This is an indicator of soil and/or water pressure causing inward deflection of the wall and impending failure. In this case, water drainage toward the foundation had caused an excessive hydraulic load. Lack of maintenance of gutter drainage and grade near the wall has in-

creased hydraulic loading against the wall over time. These cracks are a result of hydraulic and soil pressure.
