Claims[®]

Flexible Gas Connector Failures Impact Related Damage

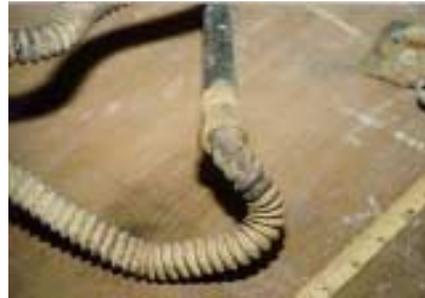
Figure 1b. This cycle can occur over several years resulting in crack formation in the brass flexible connector or in loosening of the end fitting. Figure 2 is a view of a flexible gas connector removed from a home

after an explosion had occurred. The connector and stove were over 20 years old. The homeowner had, repeatedly over the years, cleaned behind the stove by moving it out and then shoving it back against the wall. Figure 2 shows the connector after removal from the stove.

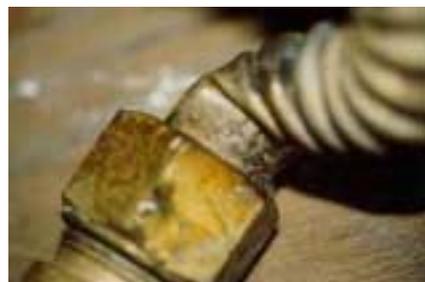
Figure 3 is a close-up of the end damage to the fitting. The impact with the wall had crimped the tubing, causing a crack and leakage.

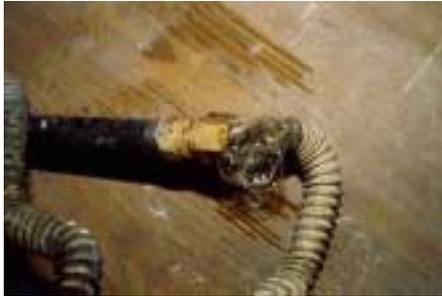
Figure 4 shows the soap solution pressure test. The crack was verified to be in the brass tubing at a crimp formed from the impact damage.
