# Gas Valve Failure Analysis\*

Charles C. Roberts, Jr., Ph.D., P.E.

\*Reprinted from "Claims Magazine"

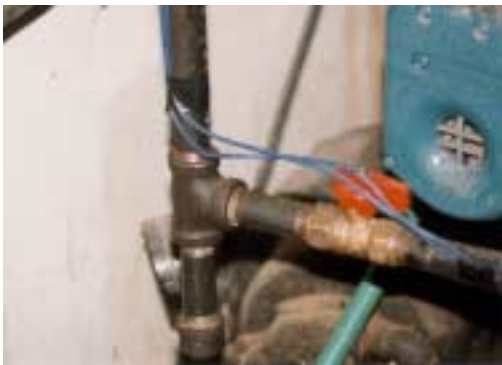
Most building mechanical codes require a sediment trap in the gas line, often called a drip leg. Figure 1 is a view of a typical drip leg. Theoretically any debris that flows toward the gas valve will be snared by the drip leg. Figure 2 is a view of contaminants in a water heater gas valve. These contaminants accumulated on

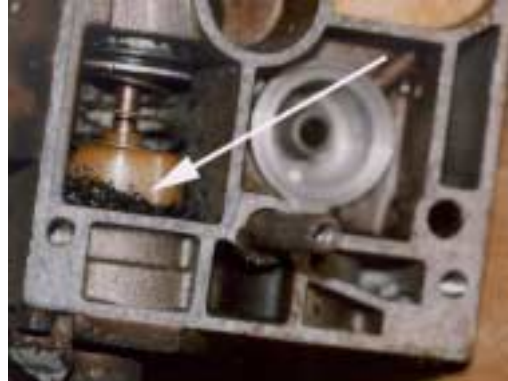
Figure 2

valve seats allowing gas flow when the heater was in the off position. This resulted in gas leakage and an eventual explosion. The contaminants were analyzed and found to be copper sulfide, a byproduct of the reaction between odorant in the gas and copper. It was found that a copper tube was used to connect the gas service to the water heater without using a drip

leg. In this case, the two deficiencies were the use of a copper line in gas service with a sulfur based odorant and the absence of a drip leg. Figure 3 is the radiograph (x-ray) of the water heater gas valve showing internal components. An x-ray is a valuable tool in analyzing the condition of a gas valve prior to disassembly since it is a nondestructive testing method.

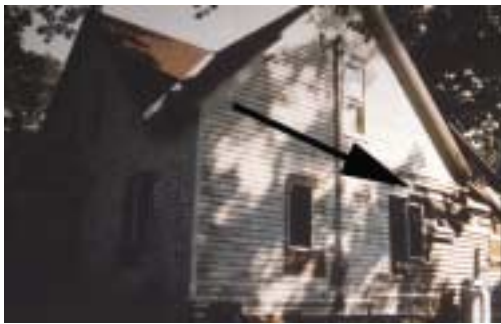
Figure 4 is a view of a home that sustained an explosion in the basement. The arrow points to structural damage at the wall. Figure 5 is a view of the water heater which was being lit by the home owner when the explosion occurred, causing serious burn injury. Apparently the home owner was in the habit of allowing the

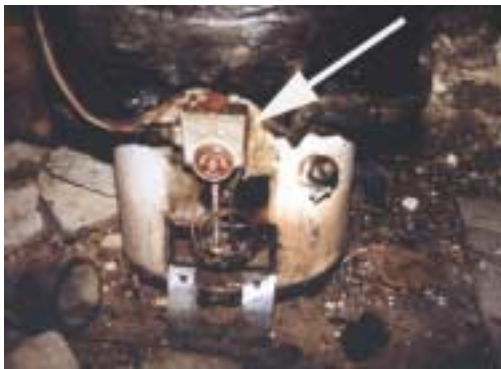
Figure 5

propane gas tanks to become empty before calling for a refill. The gas valve on the water heater was an old design that had been recalled because of intermittent operation of the flame failure safety shut off. With this particular valve, one could turn the gas valve control knob from pilot to on when the pilot light was out. This caused damage to the valve which did not close during flame failure. When the homeowner went into the basement to light the water heater, he was unaware that gas was flowing through the gas valve due to an open main valve. An unfortunate synergism had occurred in that the propane gas that had just been delivered was not supplied with odorant. Consequently, he did not smell the leaking propane.

Since propane is heavier than air, a pool of gas had accumulated on the floor which initiated an explosion when a flame was struck to light the water heater.

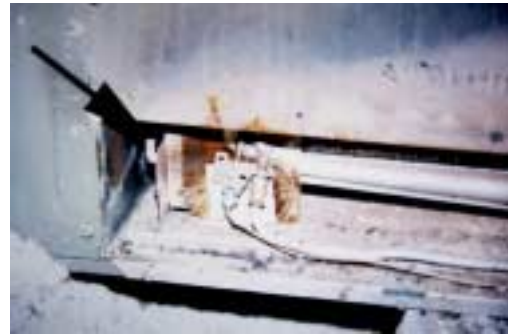
Some gas valve related failures are a result of field expedients often called "jury-rigs." Figure 6 shows a flattened tin can being used as a baffle to prevent the pilot flame from being extinguished by down drafts. The problem with this "new design" is that when the thermostat calls for heat and the gas valve opens, it becomes very difficult for the pilot flame to communicate with the raw natural gas at the burners. Consequently a large amount of natural gas flows from the burners before ignition occurs. This results in several large flash ignitions of the natural gas, with one such ignition finally igniting nearby combustible materials.
