Concrete and Masonry Wall Failure Analysis

Failures of concrete and masonry walls occur for a variety of reasons. Identification of the failure mode helps determine the status of coverage for the particular loss. The following are examples of typical concrete and masonry wall failures along with some ideas on how to identify the cause of failure.

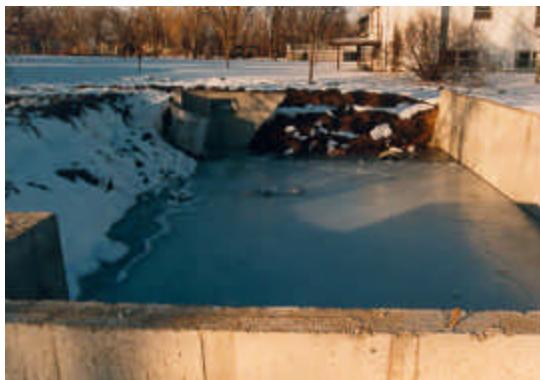
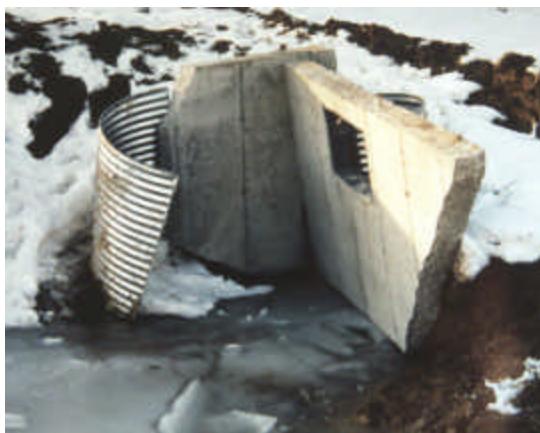
Figure 1

Figures 1 and 2 are views of a failure of a newly poured concrete basement wall. The building contractor back-filled the wall prior to framing of the residential home. Almost

immediately after back-filling was completed, heavy rains occurred. This resulted in a saturated soil condition and severe hydrau-

lic pressure against the wall. Since the walls were not supported by the building structure or a slab, severe cracking and failure occurred at the highest stressed areas: about halfway between the corners of the building. In this case, it is better practice to wait until the building structure is complete and floor slab installed before back-filling at the foundation wall.

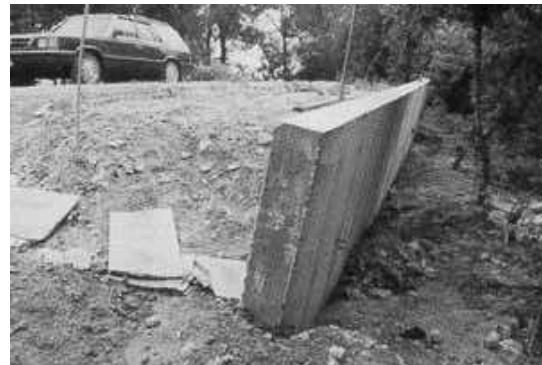
Figure 3 is a view of a severe deflection failure of a concrete retaining wall. This wall was designed without a support structure such as a pilaster, bracing or tie back system. The back fill was clay soil, without a gravel back fill, which aggravated the drainage near the wall. During heavy rains, hydraulic pressure increased, causing failure of the newly poured wall.

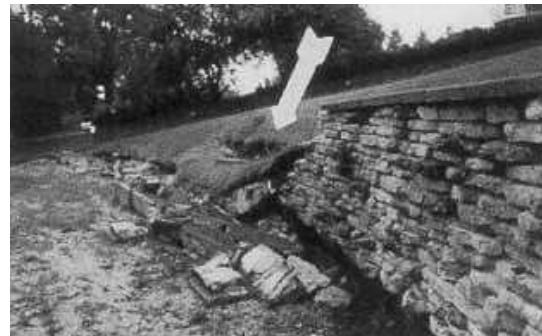
Figure 4 shows a similar failure of an older existing wall. It suffered from similar deficiencies with the exception of water drainage. There apparently had been good drainage around the base of the wall, but over the years the tiles had failed and became blocked. Eventually, as is typically so during a heavy rain, the wall gave way. Although the inspection of the wall was several months later during a dry spell, the shearing of moisture laden clay as indicated by the arrow is quite apparent.

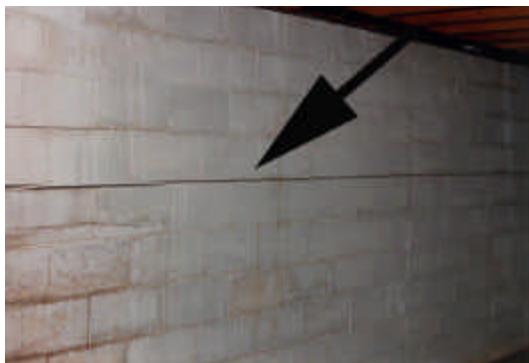
Figure 5 is a view of an un-reinforced concrete block wall that is failing as a result of soil and hydraulic pressure. The wall is deflecting inward into the basement as shown by the large crack. As the wall deflects more, a cavity develops on the outside that allows soil and water to back fill, resulting in more pressure and more deflection. This failure is a result of insufficient support of the wall. Pilasters and reinforcing rod significantly reduce this type of deformation. Some municipalities do not allow concrete

block construction of this type without reinforcement.

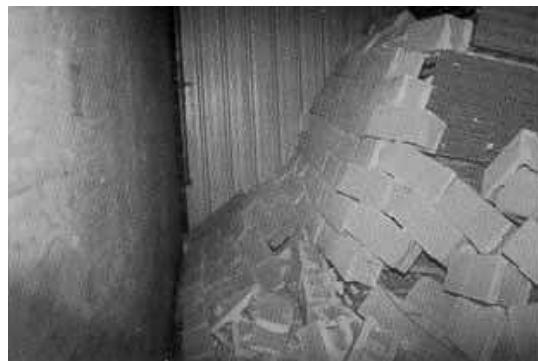
Figure 6 is a view of an interior partition wall in a warehouse that failed when large loading doors were left open during a sudden storm. Although the wind pressure against the wall was low, the total force against the wall was substantial, causing a bending failure to the un-reinforced wall.
